# Manhole Inspection Summary

Manhole # S29K\_\_011MH

Insp Date: **11/16/08 10:39 AM**

**Location** Address: **1055 W Barre St**

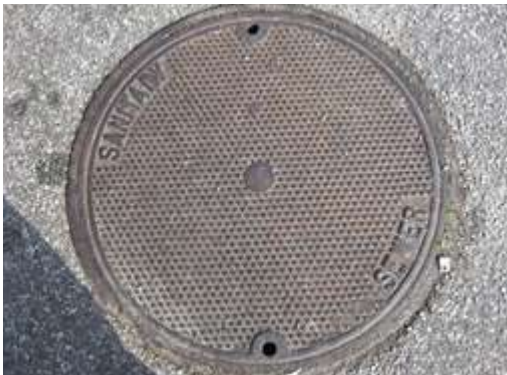
misc-2

cover pic

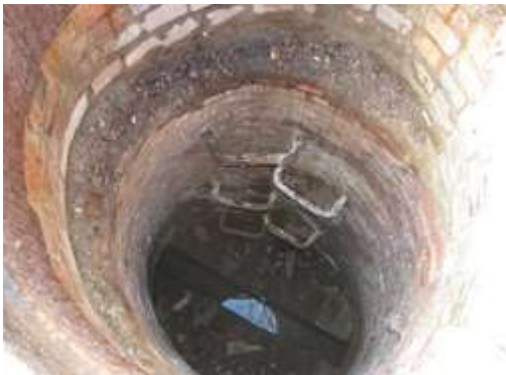
misc-1

additional Top View

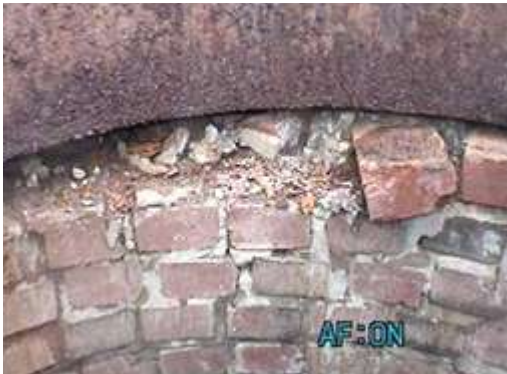
misc-5

miising bricks and broken bricks

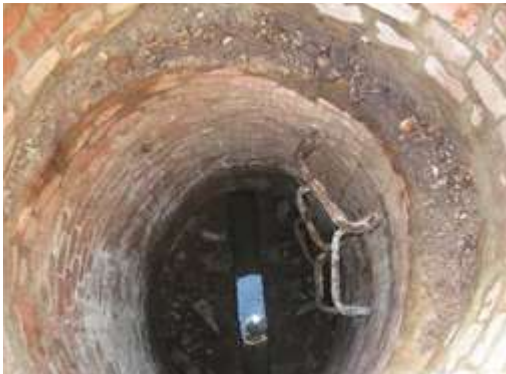
Misc-6

chimney offset

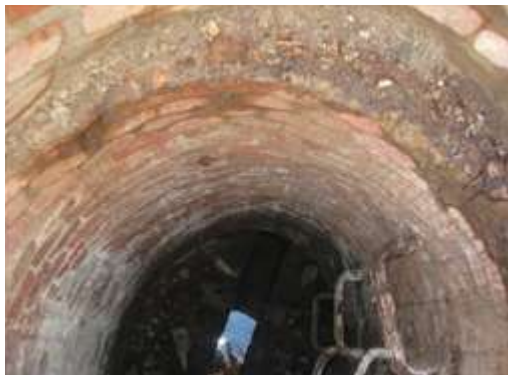
misc-5

barrel offset

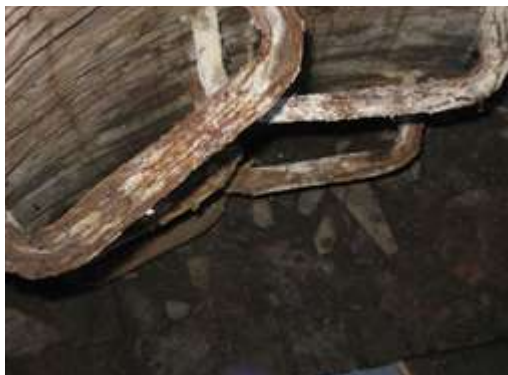
Defect 3

**Steps** Count: **6** Missing: **0** ☒ **Corroded**

corroded rungs

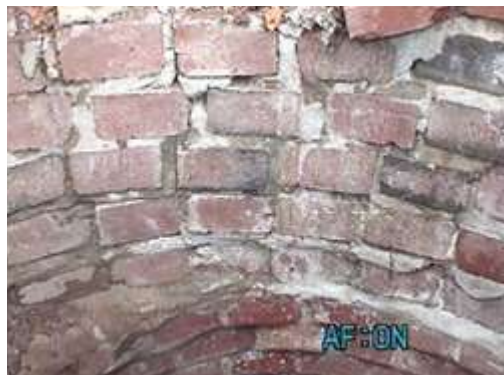
Defect 7

Condition: ☐ Sound ☒ **Cracked** ☐ Root Intrusion ☒ **Loose Brick** ☒ **Deteriorated**

chimney deteriorated

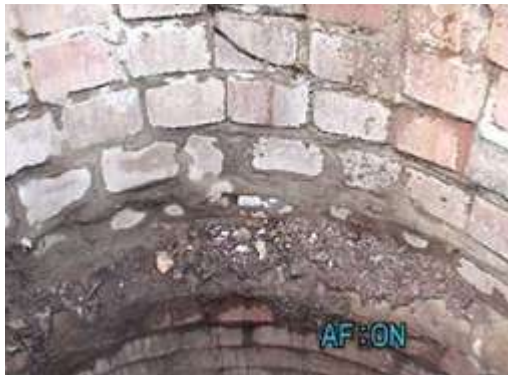
Defect 6

cracked brick in chimney

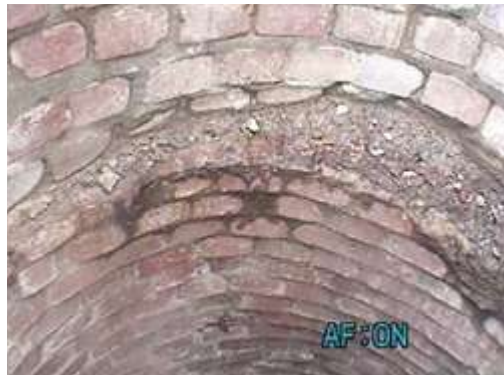
Defect 5

Infiltration: ☐ None ☒ **Joint** ☐ Cracks ☐ Mortar ☐ Roots ☐ Wall

corbel barrel offset joint infiltration

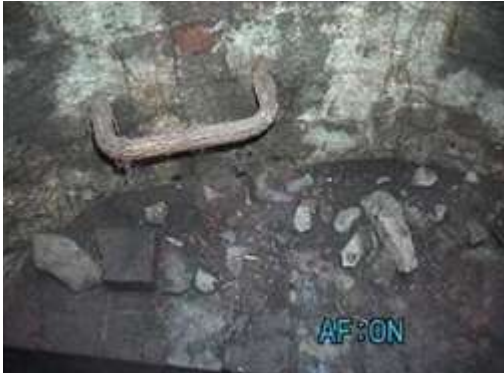
Defect 4

Condition: ☐ Sound ☐ Cracked ☐ Root Intrusion ☐ Deteriorated ☐ Leaks ☒ **Debris**

debris on bench

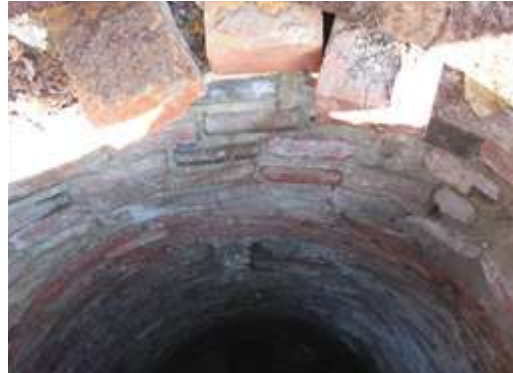
Defect 2

chimney has loose bricks

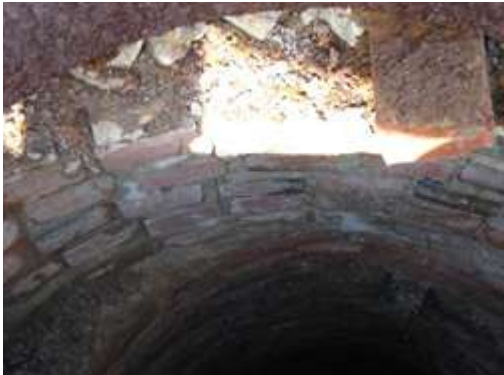
Defect 1

**Frame** Offset: **3.5** (in.) Condition: ☒ Sound ☐ Cracked ☐ Leaks

3.5 inch frame offset
